## EMERGENCY RESPONSE SUPPORT – BIOLOGICAL PRODUCT APPLICATION DIESEL FUEL PIPELINE RELEASE Tampa, Florida area

<b>Type of Project:</b>	Emergency Response/Interim Remedial Action
<b>Contaminants Treated:</b>	Diesel fuel
<b>Concentration:</b>	Unknown soil/GW concentrations within excavation boundaries
<b>Technology Applied:</b>	Bioremediation
<b>Geology:</b>	Medium to fine sand
<b>Treatment Interval:</b>	Sidewalls, floor of excavation (0 to 20 feet bgs)
<b>Average % Reduction:</b>	Unknown
<b>Timeframe:</b>	1 week
<b>Project Reference:</b>	Josh Hirten, URS Corporation (407) 992-5056

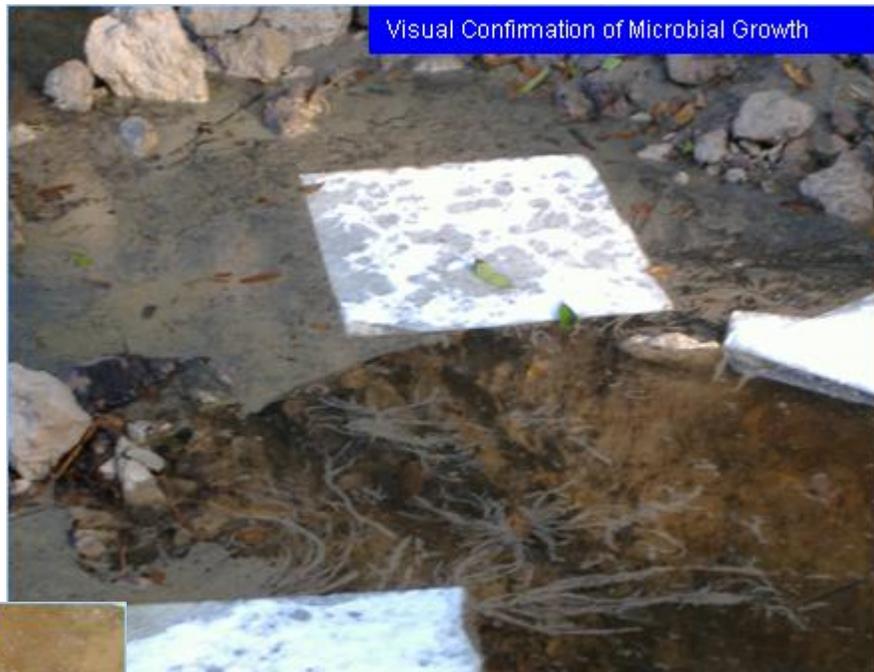
Within 48 hours of biological product application to the most heavily-impacted groundwater zones (see pads which were placed to soak up free-phase fuel), exponential microbial growth was evident to the naked eye.
